#### **BELVEDERE CLUB 2019 ARCHITECTURAL INVENTORY**

Site: 25 Historic Name N/A

### Year Built c. 1890 Architectural Style Shingle style

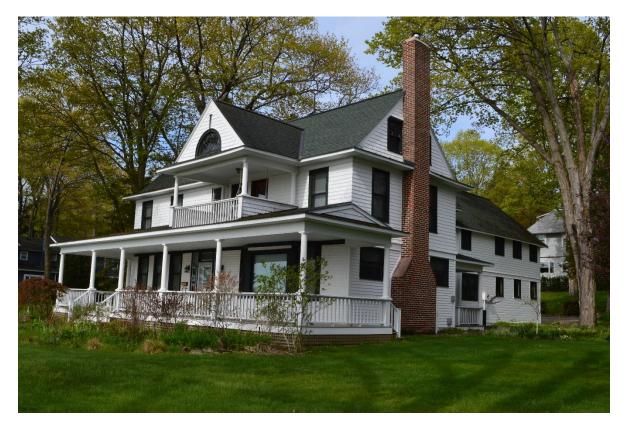
The two-story cottage has narrow clapboard siding at the first floor and shingle siding at the second floor, the shingles typical of the Shingle style. The first and second floor porches are seen on seaside examples of the style and the lunette in the gable dormer with Colonial Revival details is another characteristic feature. The first and second story porches originally had paired Doric columns supported by a shingle knee wall with railings in between. There was an internal cobblestone chimney in the north gable that has been replaced with an external brick chimney. The original two-over-two windows have been replaced with one-over-one windows.

The cottage is in good repair no issues are apparent.
