BELVEDERE CLUB 2019 ARCHITECTURAL INVENTORY

Site: 43

Architectural Style Shingle style

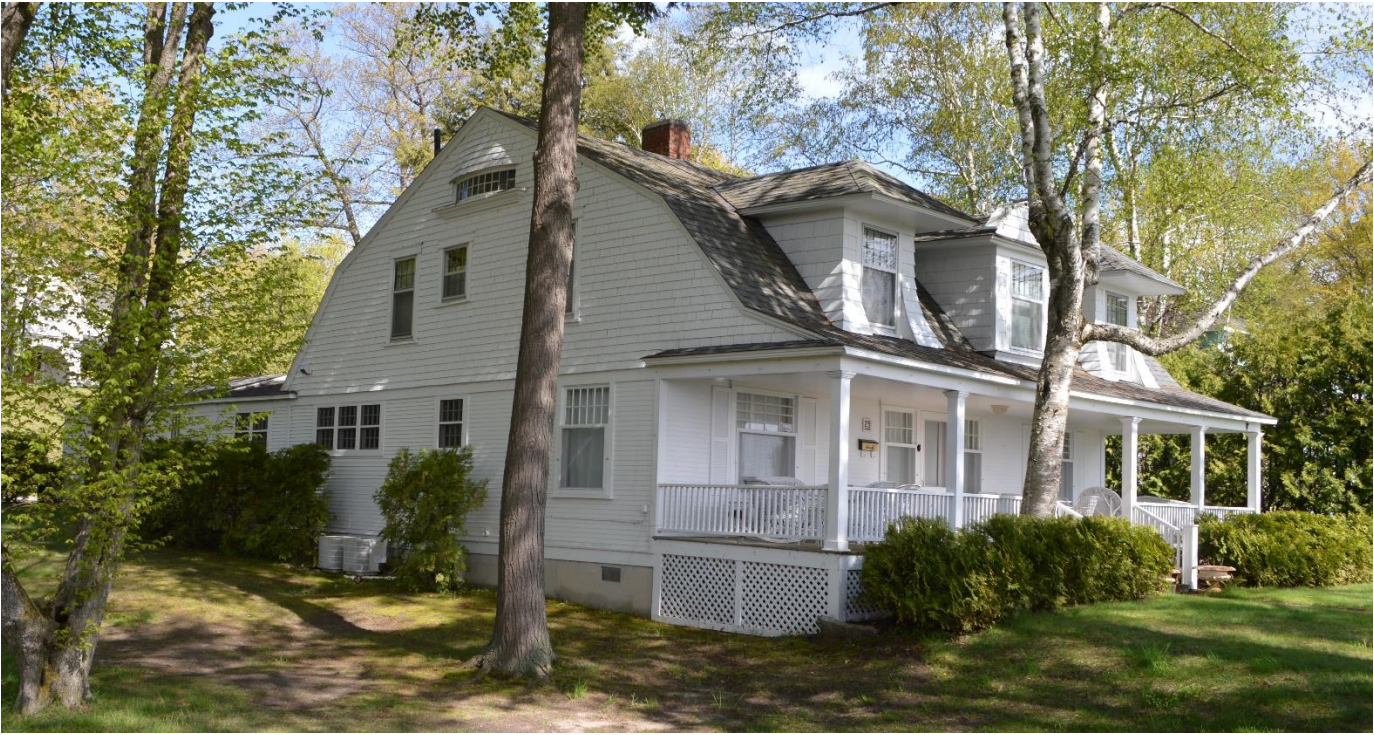
The cottage is generally in good repair with no apparent issues.
