BELVEDERE CLUB 2019 ARCHITECTURAL INVENTORY

Site: 401

Year Built c. 1890

Architectural Style Queen Anne

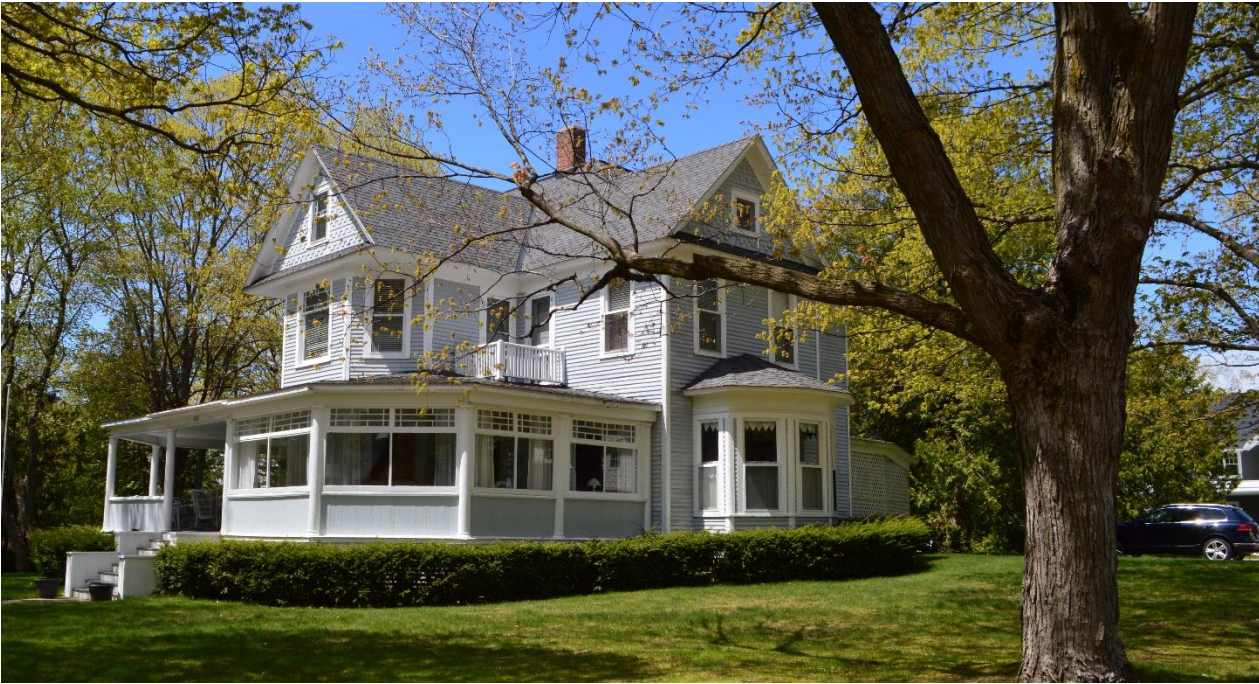
The cottage appears to be in good repair with no apparent issues.
