BELVEDERE CLUB 2019 ARCHITECTURAL INVENTORY

Site: 507 **Historic Name** N/A
Year Built c. 1900
Architectural Style Shingle style

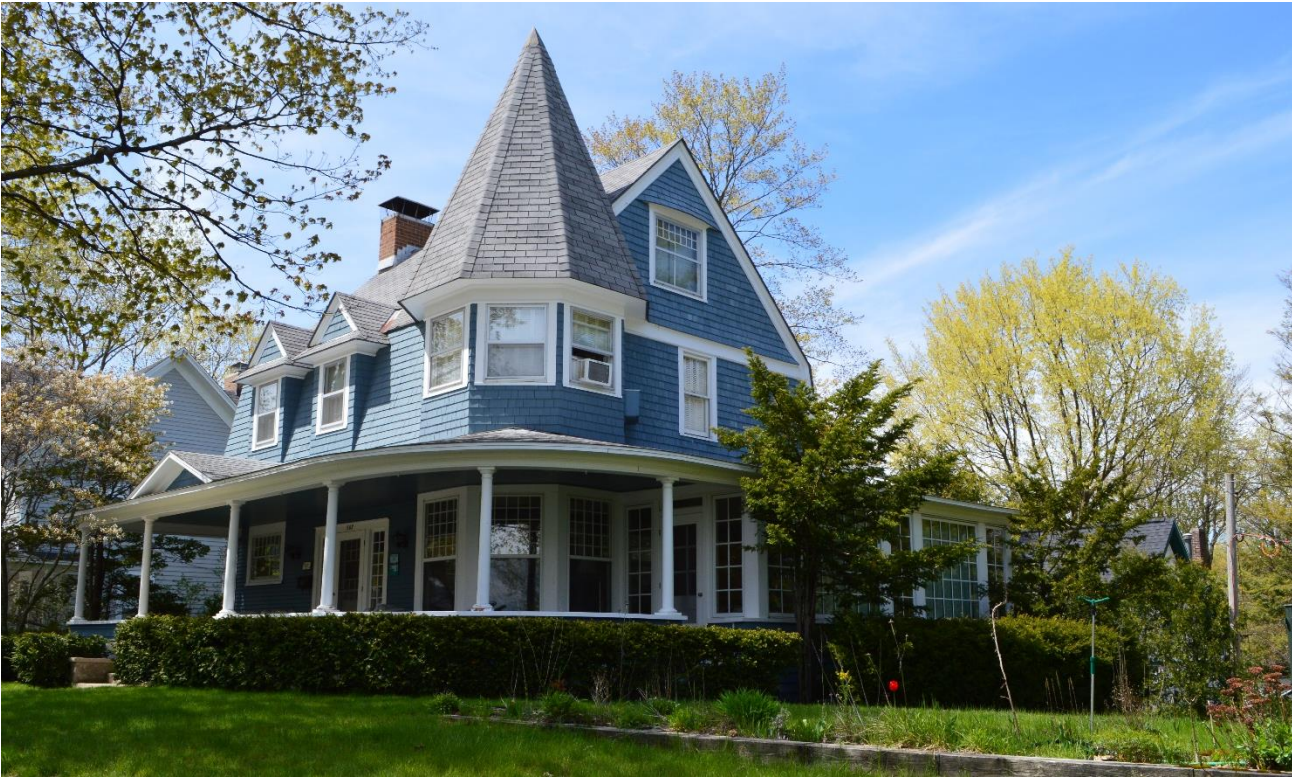
The cottage appears to be in good repair, no apparent issues. It retains most of its original appearance.
