BELVEDERE CLUB 2019 ARCHITECTURAL INVENTORY

Site: 513 Historic Name N/A

Year Built c. 1900

Architectural Style Shingle style

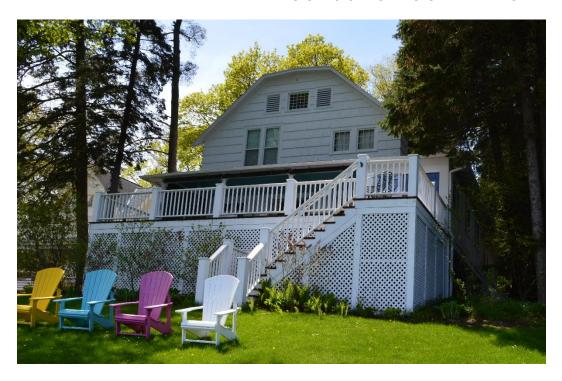
The front gambrel roof with clipped gables at the front and rear of the house and full width front porch with shallow pitched roof supported by Doric columns, along with the multi-pane windows are indicative of the Shingle style. The first floor has narrow clapboard siding, the upper floor likely had wood shingles but has been replaced with wide artificial shingle siding.

The cottage appears to be in good repair, no apparent issues.
