#### **BELVEDERE CLUB 2019 ARCHITECTURAL INVENTORY**

Site: 404 Historic Name N/A

Year Built c. 1900

Architectural Style Shingle style

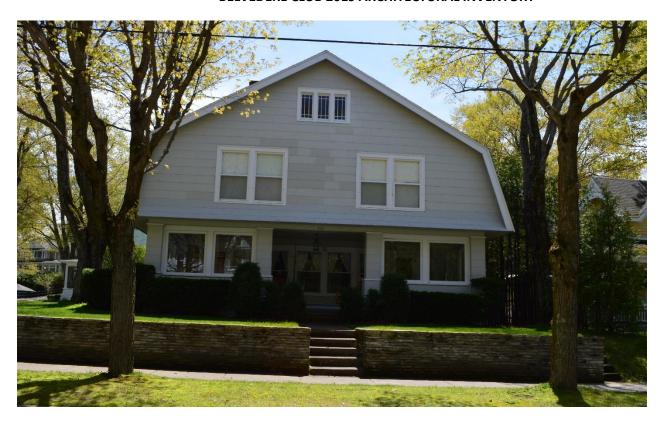
Although the siding has been replaced with an artificial siding representing shingles, the large gambrel front roof that has a flared bottom and overhangs the first floor creating a deep recessed front porch with large square shingle sided pillars are typical of the Shingle style massing. The decorative windows in the gable end are also typical of the style.

- Large gambrel front roof with flared bottom that overhangs the first floor creating a deeply recessed front porch with large square pillars and central stair.
- Decorative windows in the north gambrel end.
- Shed roof dormers in the sides of the gable roof are typical of the style.

The cottage appears to be in good repair with no apparent issues.
