BELVEDERE CLUB 2019 ARCHITECTURAL INVENTORY

Site: 507 **Historic Name** N/A
Year Built c. 1900
Architectural Style Shingle style

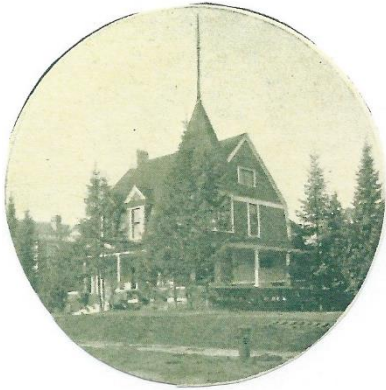
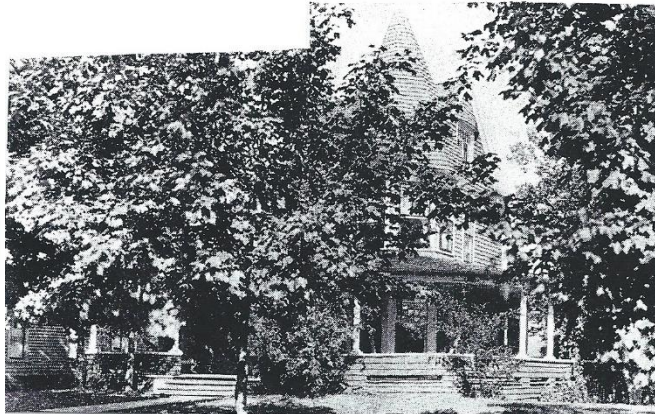
ADDITIONAL PHOTOS - 1907 and unknown

The cottage appears to be in good repair, no apparent issues. It retains most of its original appearance.
