## BELVEDERE CLUB 2019 ARCHITECTURAL INVENTORY

**Site:** 6

**Year Built** c. 1910

**Architectural Style** Craftsman

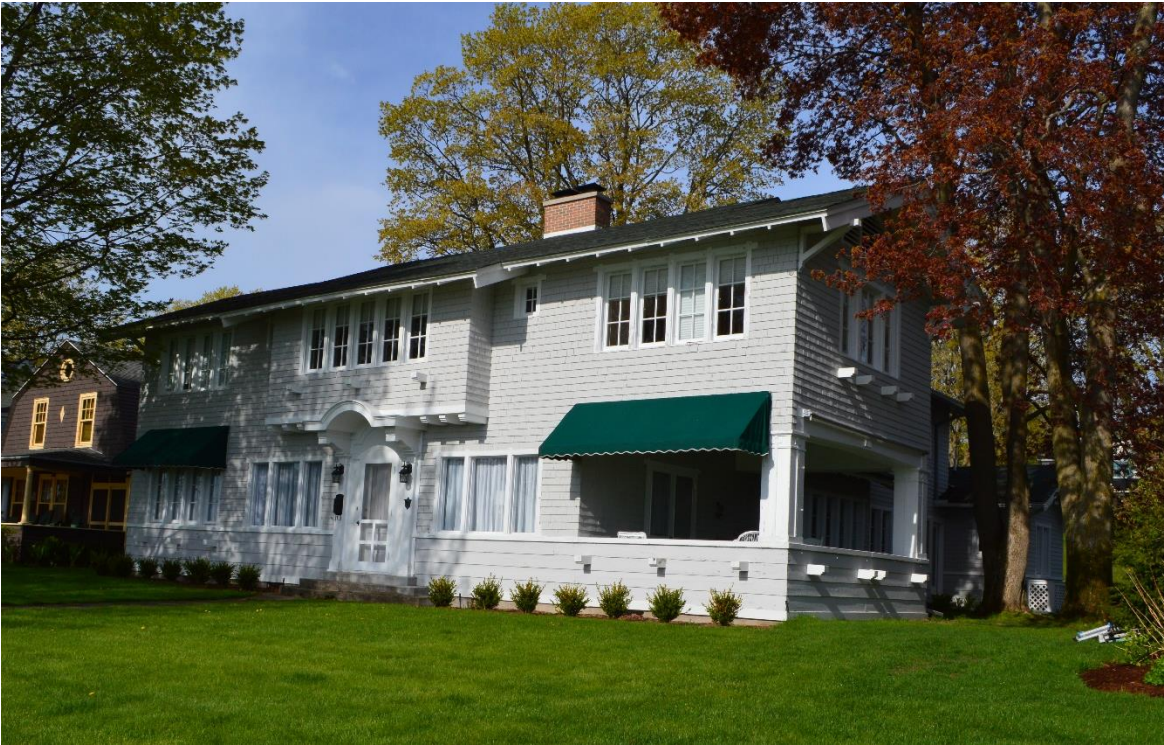
Like Cottage 3 this cottage features Craftsman style elements with an unusual massing with the porch recessed under the second floor at the north end. Two-stories tall the façade is not quite symmetrical but still creates a balanced appearance due to the symmetry of the second-floor windows. The projecting bay above the front door is supported by brackets and creates an arch giving the house a small Tudor revival element.

- The side gable roof with exposed rafter tails and deep overhang that sits just above the second-floor windows.
- The shingle siding, along with the wide clapboard siding around the base of the building.
- The heavy wood porch pillars and wood projections through the base walls of the porch, the second story bay, and the front of the building. It appears these projections originally supported planter boxes.
- Some of the original multi-pane wood windows remain along with the original wood trim.

The cottage is generally in good repair.
