## BELVEDERE CLUB 2019 ARCHITECTURAL INVENTORY

**Site:** 7                      **Historic Name** N/A

**Year Built**            c. 1900

**Architectural Style**    Dutch Colonial Revival

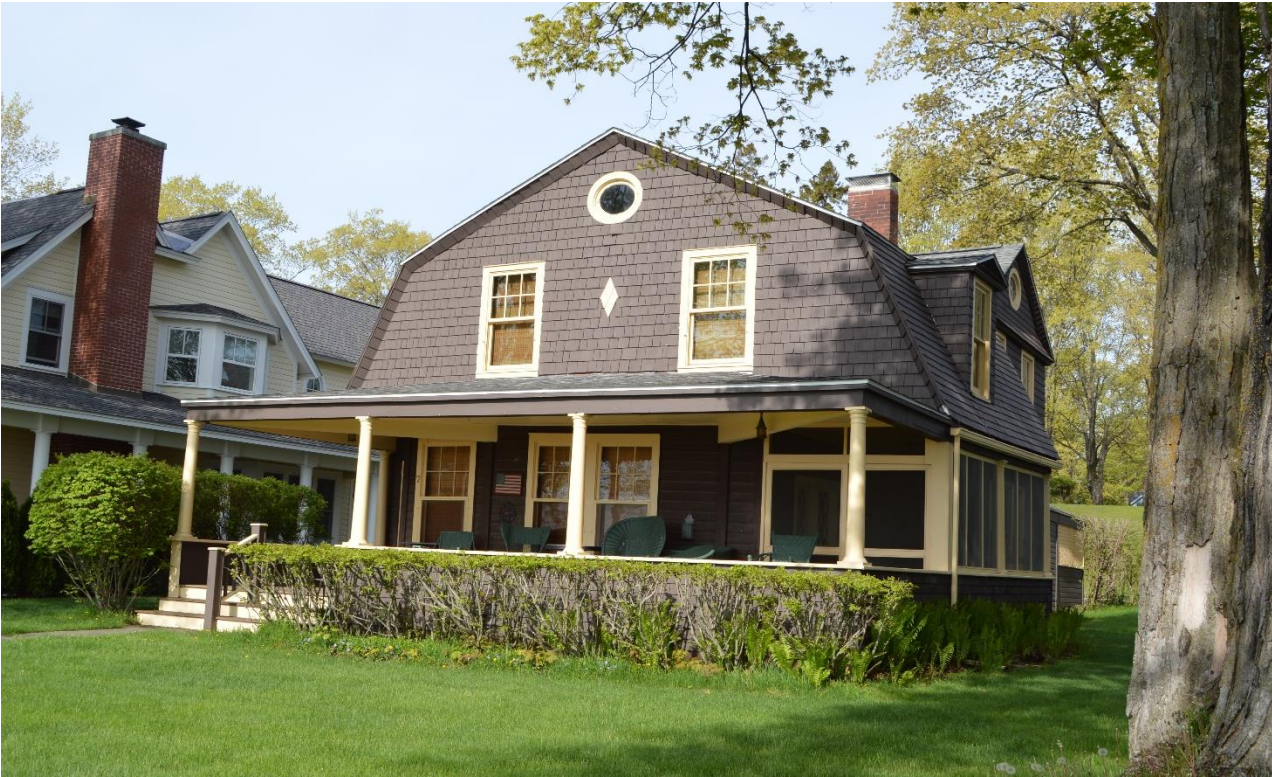
Two-story tall cottage with a front-facing gambrel roof which was a popular form between 1895 and 1915. There are dormers in the sides of the roof and a cross-gable at the rear, other popular subtypes of this form. The cottage is clad in shingle siding and has a circular window in the peak of the gambrel. The symmetrical second floor windows offset the asymmetrical first floor openings which are behind a full width hipped roof porch that wraps around to the sides. The Doric columns supporting the porch roof resting on the solid knee wall are typical of the style.

- The front-facing gambrel roof that encompasses the second floor and has side dormers and a cross gable at the rear.
- The shingle siding, windows and window trim.
- The heavy wood porch pillars and wood projections through the base walls of the porch, the second story bay, and the front of the building. It appears these projections originally supported planter boxes.
- Some of the original multi-pane wood windows remain along with the original wood trim.

The cottage is generally in good repair and retains most of its original features.
