BELVEDERE CLUB 2019 ARCHITECTURAL INVENTORY

Site: 31

Architectural Style Shingle Style

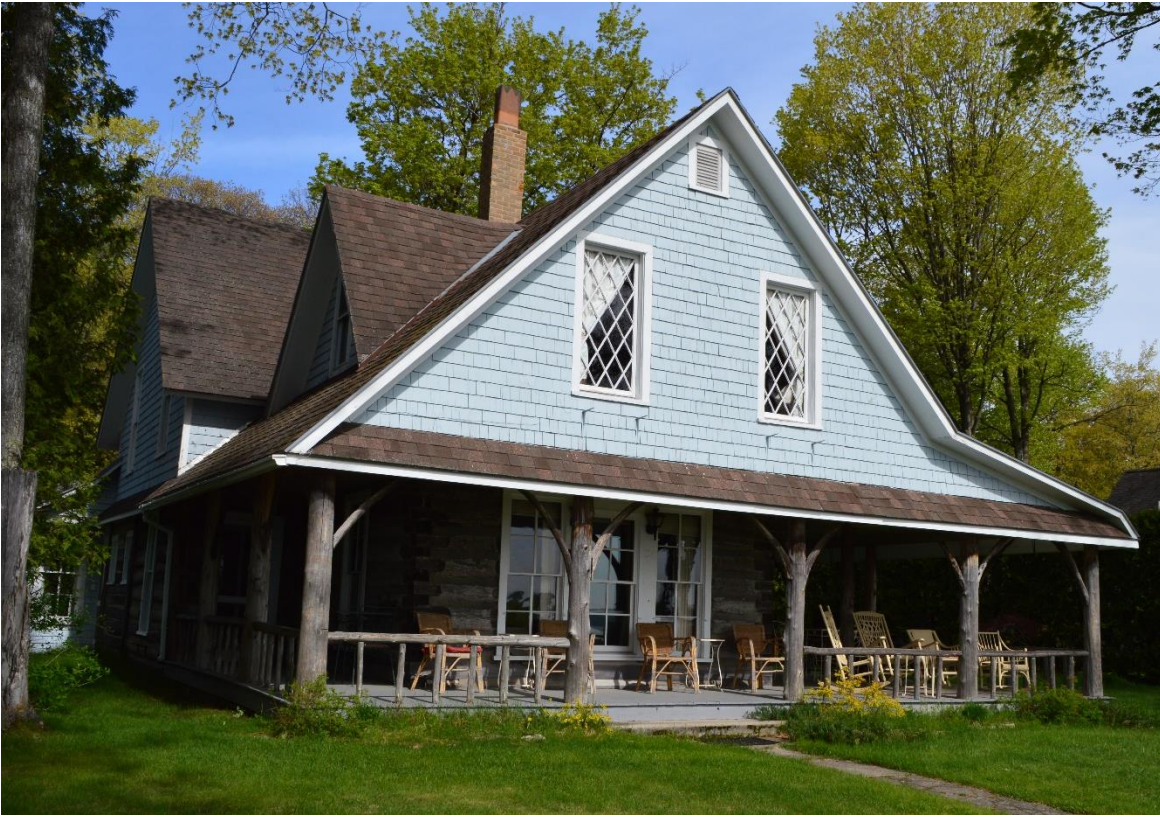
The two-story cottage is unique in the club in that the first floor is constructed of logs, and the upper story is clad in shingles. The shingles and massing, including the gable front with two diamond pane windows and cross gables are indicative of the Shingle style. The log first floor makes this an unusual adaptation of the style.

- Log first floor with shingle siding at second floor.
- Full width front porch with log supports and brackets.
- Diamond pane and four-over-four windows – various locations.
- Large gable front and cross gables and gable dormers.

The cottage is in good repair no issues are apparent.
