BELVEDERE CLUB 2019 ARCHITECTURAL INVENTORY

Site: 37 Historic Name N/A

Year Builtc. 1901Architectural StylePrairie

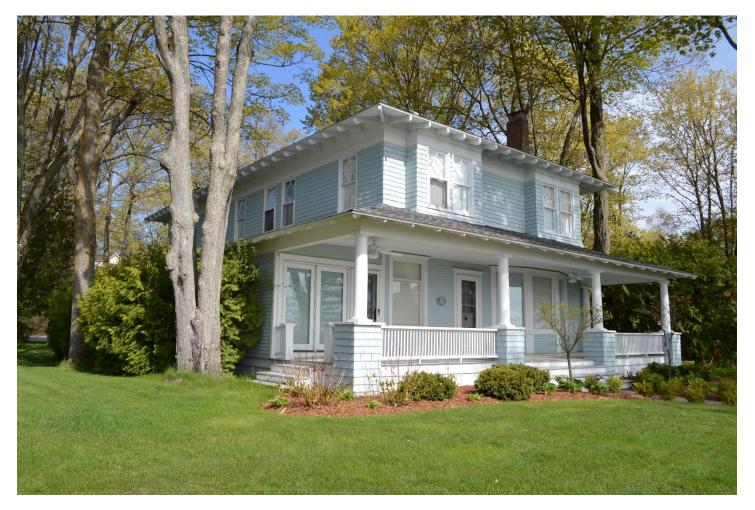
The shallow hip roof with exposed rafter tails and rectangular massing of this two-story cottage are indicative of the Prairie style as is the narrow clapboard siding on the first floor and shingle siding on the second floor. The full width front porch which wraps around the south side is original, although the side portion has been enclosed. The Doric columns on shingle knee walls at the front porch are original. A square window originally between the two second floor bays has been removed.

- Shallow pitch hip roof with exposed rafter tails and rectangular two-story massing.
- Doric porch columns supported by shingle knee walls with railing in between.
- Large diamond pattern in windows.
- Two projecting bays at second floor.

The cottage is in good repair no issues are apparent.

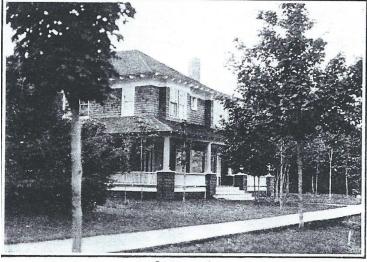
Cottage of Mrs. Mary R. Rockwell, Chicago, III. 1916
