BELVEDERE CLUB 2019 ARCHITECTURAL INVENTORY

Site: 41

Year Built c. 1905

Architectural Style Craftsman style

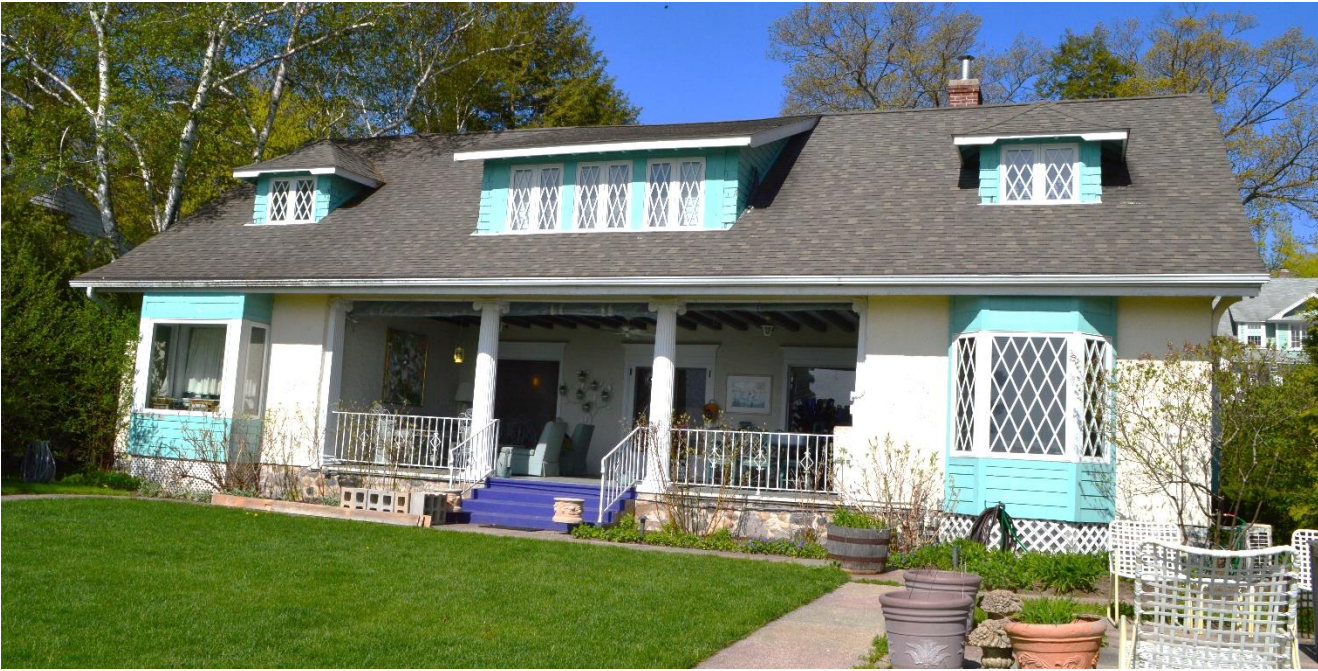
The large side gable roof with shed roof dormers and deep overhangs along with the deep recessed porch with fluted Ionic columns and pilasters of this one-and-half-story cottage are indicative of the Craftsman style as is the stucco walls on the first floor and shingle siding in the gable ends. The diamond pane windows contribute to the Craftsman style.

- Large side gable roof with deep overhangs and shed roof dormers with shingle siding.
- Shingle sided gable ends that overhang the first floor and are supported by wood brackets.
- Stucco first floor with shingle siding on the window bays.
- Diamond pane windows throughout.

The cottage is generally in good repair. The large shrubbery close to the foundation could cause moisture problems and decay in the future.

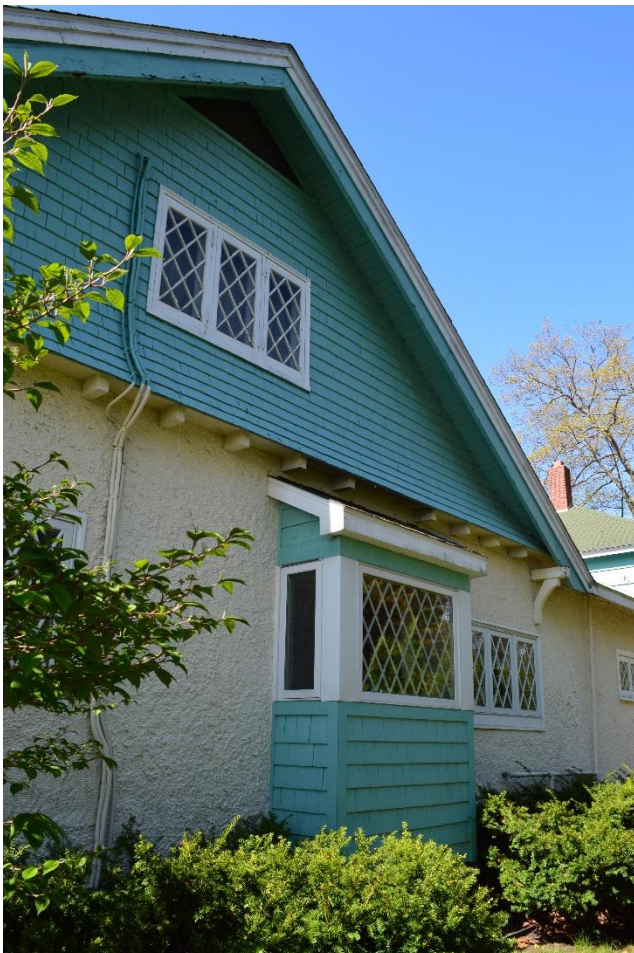
Detail of north side
