BELVEDERE CLUB 2019 ARCHITECTURAL INVENTORY

Site: 45

Year Built c. 1900

Architectural Style Queen Anne

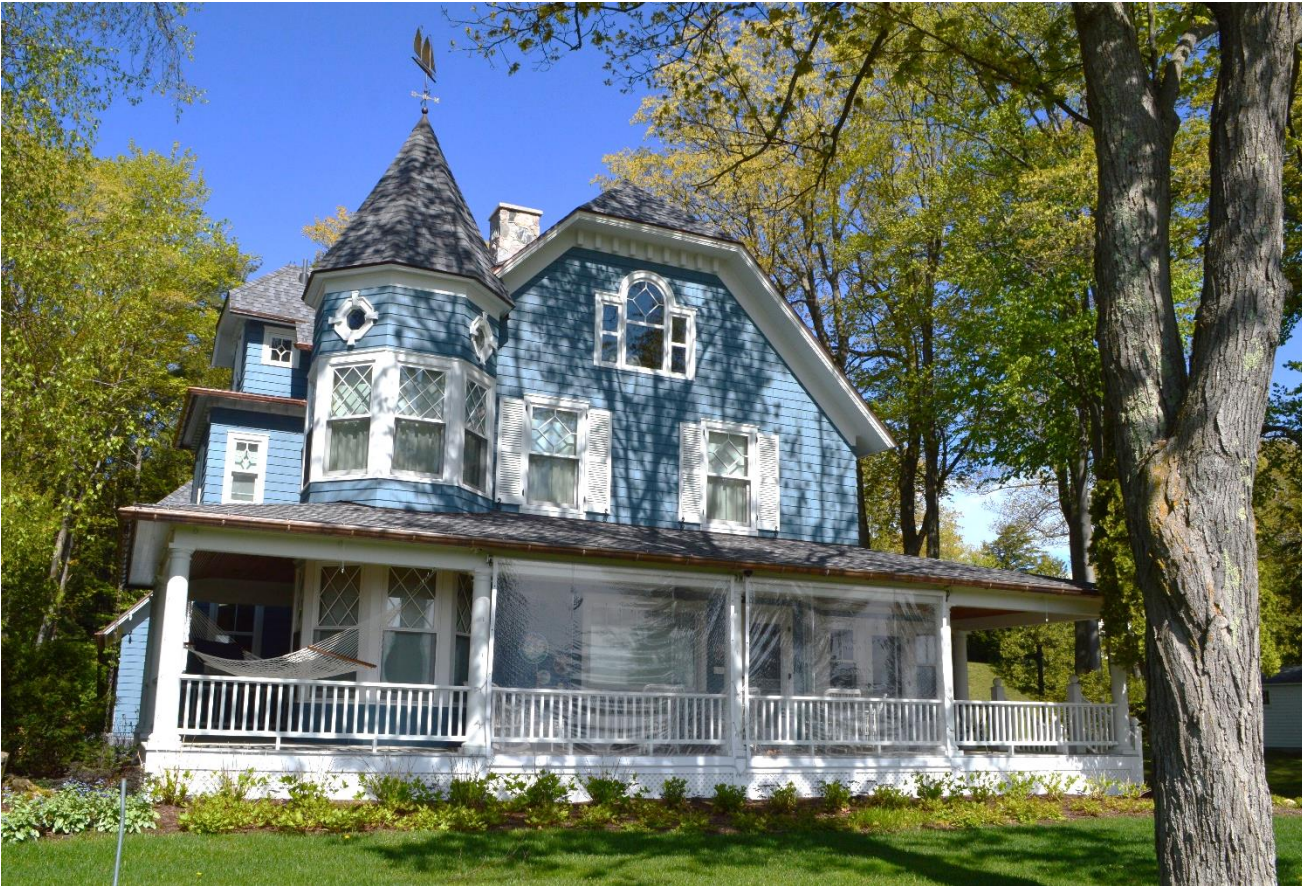
This two-and-a-half-story cottage with its wrap-around front porch, corner tower, clipped gable roof, and Palladian window has typical Queen Anne massing and features. The southeast corner of the front porch originally was multi-sided to match the angled sides of the tower. The various diamond patterns in the upper sash of the windows were not there in 2009 and it is unknown if they were there originally. It appears that the circular windows in the tower and the vertical boards above the Palladian window have been added since 2007, and the siding has been changed. The dormers in the north slope of the main roof are not original.

- Two-and-half story massing with clipped gable roof and corner tower with multi-sided roof.
- Full-width wrap-around front porch with Doric columns.
- Palladian window in the gable end.

The cottage is generally in good repair with no apparent issues.
