BELVEDERE CLUB 2019 ARCHITECTURAL INVENTORY

Site: 47

Architectural Style Queen Anne

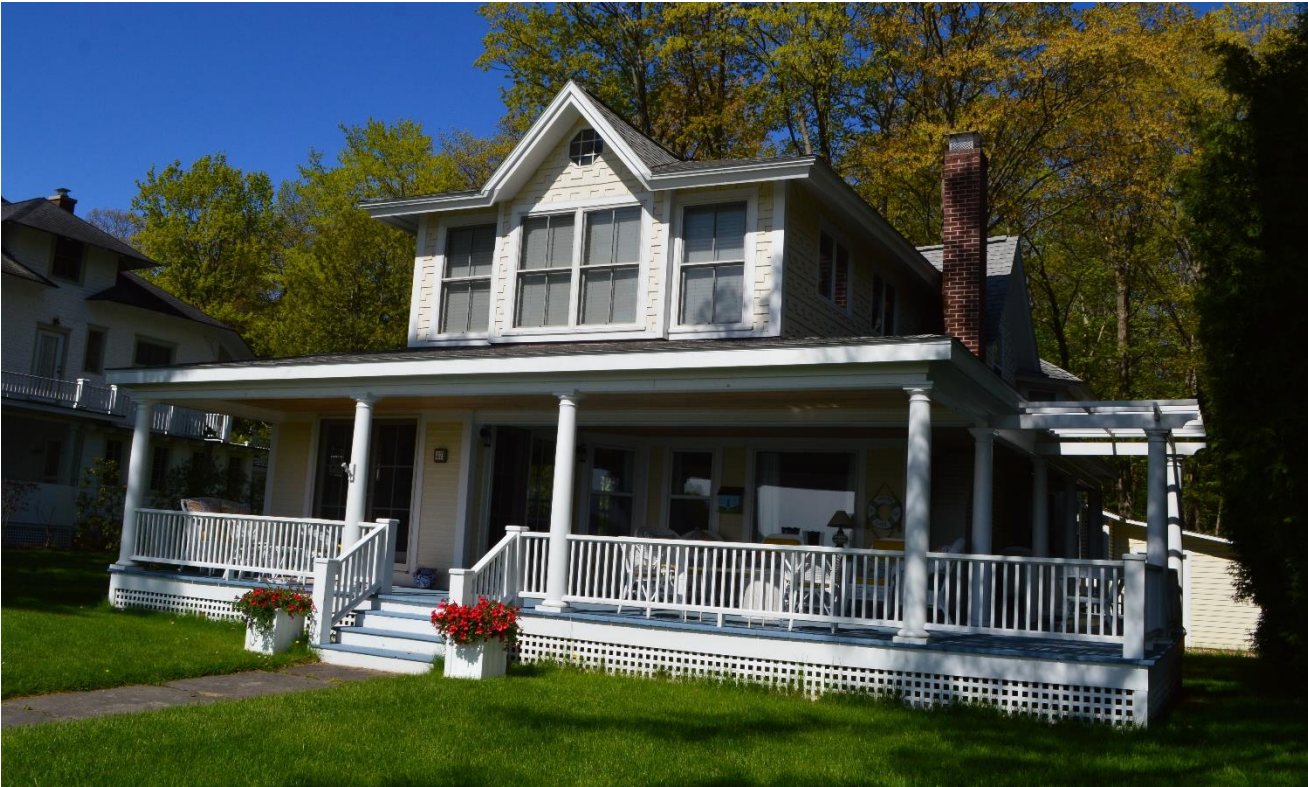
Sometime prior to 2007 this cottage was expanded at the first and second floors, eliminating the angled wall and wrap around porch with a flared roof at the first floor and a recessed second floor porch. A more recent renovation recreated the full width front porch with Doric columns.

- Full-width wrap-around front porch with Doric columns.

The cottage is generally in good repair with no apparent issues.
