BELVEDERE CLUB 2019 ARCHITECTURAL INVENTORY

Site: 101

Year Builtc. 1900Architectural StyleQueen Anne

BELEVEDERE CLUB 2019 ARCHITECTURAL SURVEY

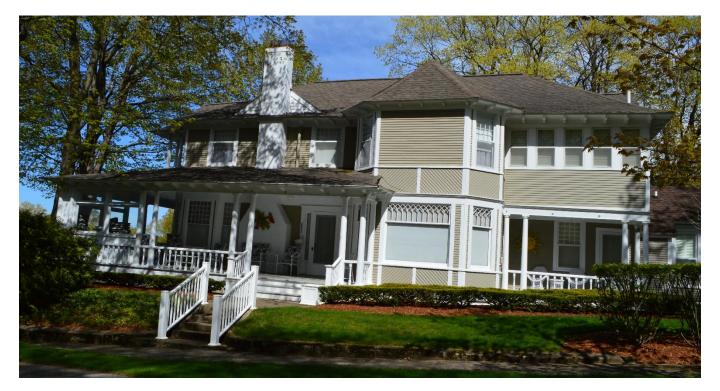
The gable front with round window over the second-story porch with paired Doric columns, along with the rectangular massing, complex roof shapes, and narrow clapboard siding are all indicative of the Queen Anne style. The deep roof overhangs have decorative brackets, and the front porch has a turned balustrade. The first-floor windows on the west elevation with the multi-paned upper sash appear to be original. The first-floor windows in the multi-sided bay are commonly found on Queen Anne style houses.

- Complex roof shapes including the gable front with round window above the second-floor porch, the multi-sided roof over the west bay, and deep overhangs with decorative brackets.
- Wrap around front porch with turned balustrade and paired Doric columns and recessed side porch at the southwest corner of the house.
- Second story porch under gable front with paired Doric columns.
- Narrow clapboard siding.

The cottage is generally in good repair with no apparent issues. It retains most of its original features.
