BELVEDERE CLUB 2019 ARCHITECTURAL INVENTORY

Site: 111 Historic Name Woodbine

Year Built c. 1890

Architectural Style Stick style

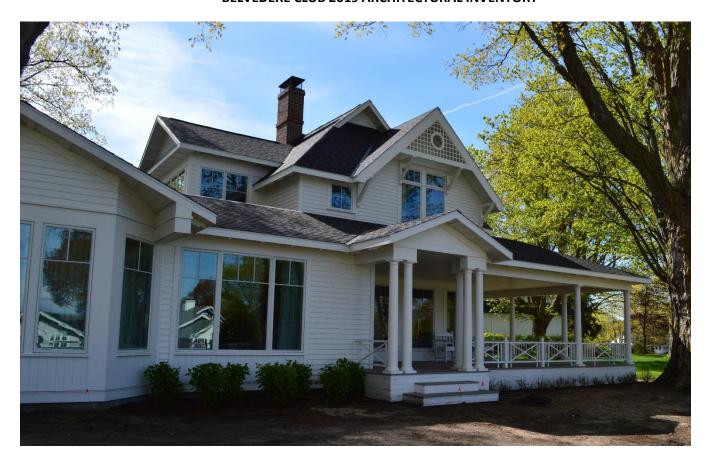
The steeply pitched cross gable roof, the clipped gable on the north side, and wood lattice in the east gable supported by brackets are characteristics of the Stick style. The wrap around porch originally had turned posts with brackets, a square pattern balustrade, and the windows were originally one-over-one.

- Wood lattice with circle supported by brackets, and brackets supporting eaves in the east facing gable.
- Brackets and clipped gable roof shape in the north facing gable. The wood pattern in the siding is similar to the original

The cottage was significantly remodeled in 2017-18 and is in good repair.
