## BELVEDERE CLUB 2019 ARCHITECTURAL INVENTORY

**Site:** 125

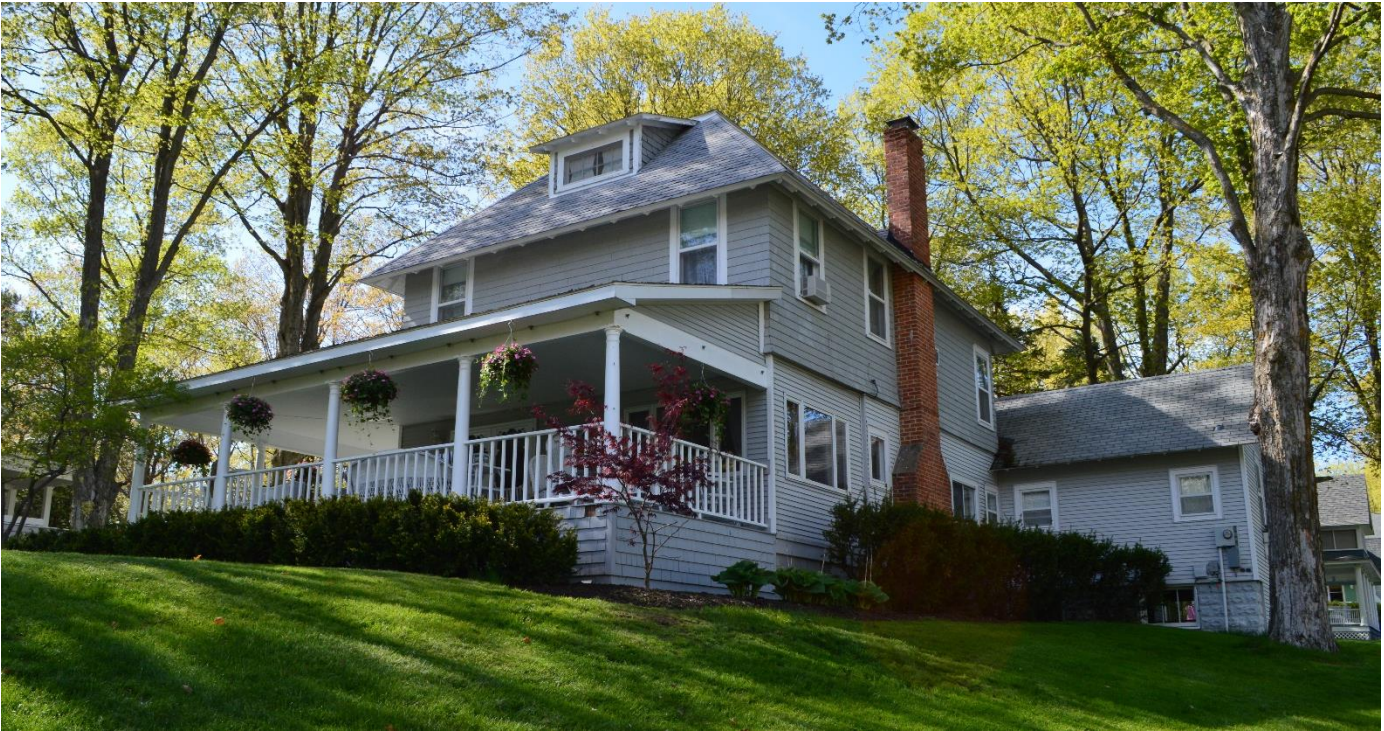
This two-story cottage with its rectangular massing and steep hip roof, deep overhangs and exposed rafter tails, along with clapboard siding at the first floor and shingle siding at the second, are all characteristic of the Prairie style. Ordinarily the porch would be limited to the front façade, but the summer resort location makes the wrap around shed roof porch supported by Doric columns appropriate.

- Steep hip roof with shed roof dormers, deep overhangs and exposed rafter tails.
- Clapboard siding at the first floor and shingle siding at the second floor.
- Wrap around porch with shed roof supported by Doric columns.
- Exterior brick chimney on east elevation.

The cottage appears to be in good repair with no apparent issues.
