## BELVEDERE CLUB 2019 ARCHITECTURAL INVENTORY

**Site:** 127

**Architectural Style** Shingle style

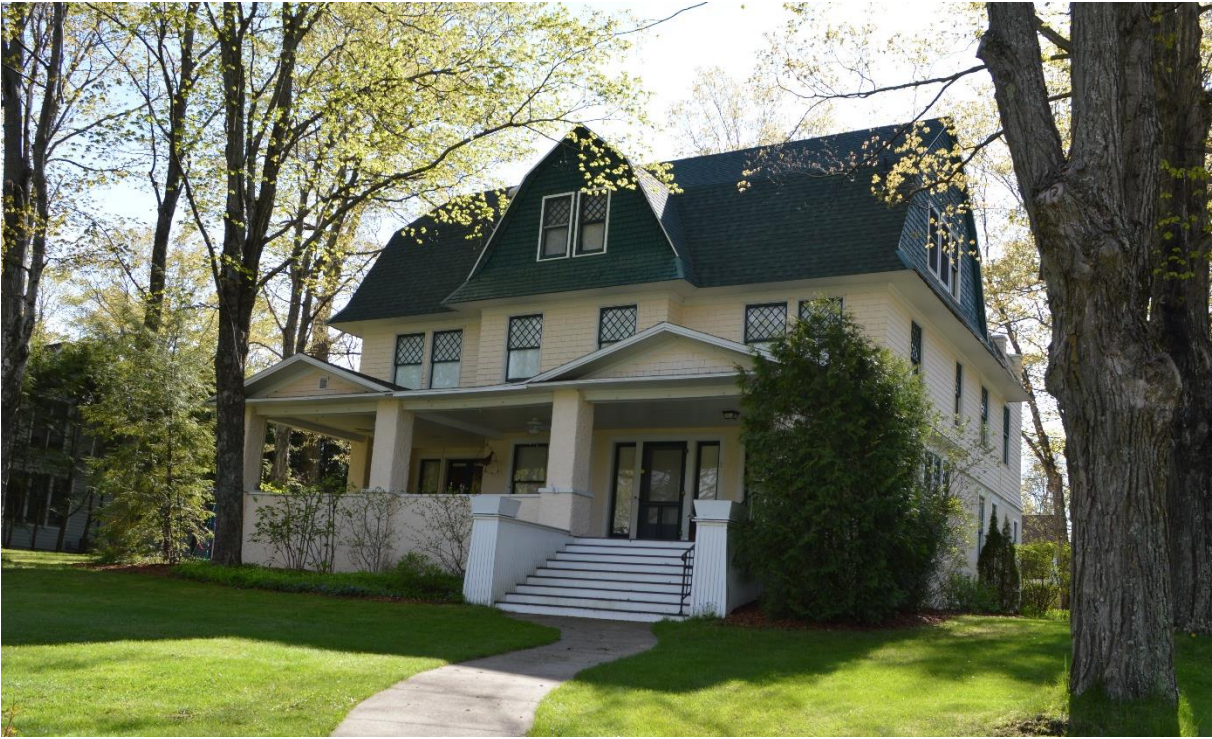
This two-and-a-half-story cottage with its cross-gambrel roof, stucco first floor, shingle sided second floor, and deep full-width front porch with stucco pillars are all typical of the Shingle style. The windows with the diamond pane upper sash, the bay windows on the north and south elevations, and the gable fronts on the full width front porch with the stucco clad knee wall, wide stair and masonry wing walls all contribute to the historic appearance of the cottage.

- Cross gambrel roof with windows in the gable ends and the flared eave across the bottom of the gable ends.
- Stucco at the first floor and shingle siding at the second floor.
- Full width porch with stucco knee walls, massive stucco pillars, gable fronts, and wide stairs with stucco wing walls.
- Bay windows on north and south elevations, all windows with diamond pattern in upper sash.

The cottage appears to be in good repair with no apparent issues.
