BELVEDERE CLUB 2019 ARCHITECTURAL INVENTORY

Site: 131

Year Built c. 1920

Architectural Style Colonial Revival with Prairie elements

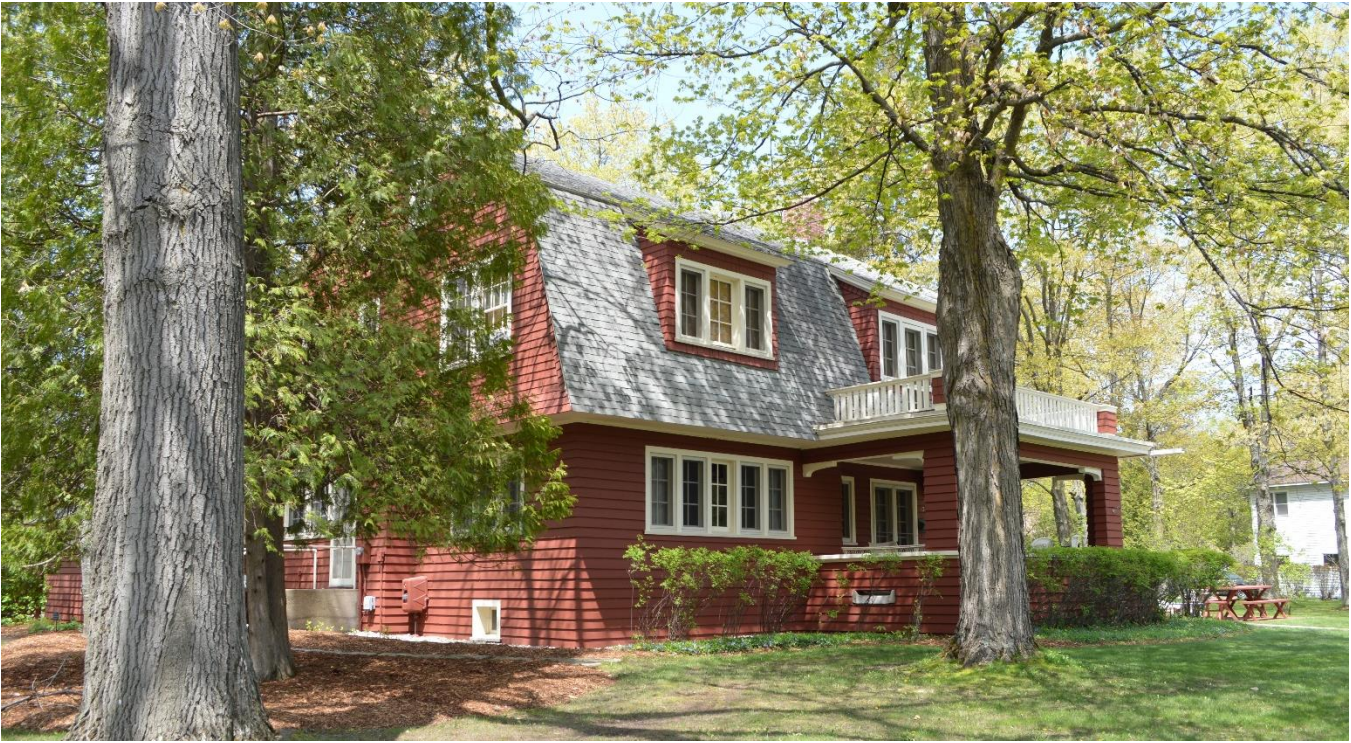
The two-story side gambrel roof with a flared bottom that overhangs the first floor and has symmetrical shed roof dormers and the symmetrical end chimneys all contribute to the Colonial Revival style of this cottage. The half width front porch with its tapered pillars, clapboard clad knee walls and pillars, and carved brackets, along with the house having clapboard siding at the first floor and shingles at the second, are all Prairie style elements.

- Side gambrel roof with flared eaves, symmetrical shed roof dormers, end chimneys, and gable end windows.
- Half width front porch with clapboard sided knee walls and flared pillars that continue through the roof to support the railing above. Brackets near the roof.
- Clapboard sided first floor; shingle sided second floor.
- Enclosed rear second floor sleeping porch with wall "scuppers" and exposed rafter tails at roof.

The cottage appears to be in good repair with no apparent issues.
