## BELVEDERE CLUB 2019 ARCHITECTURAL INVENTORY

**Site:** 135

**Historic Name** Hessy Castle

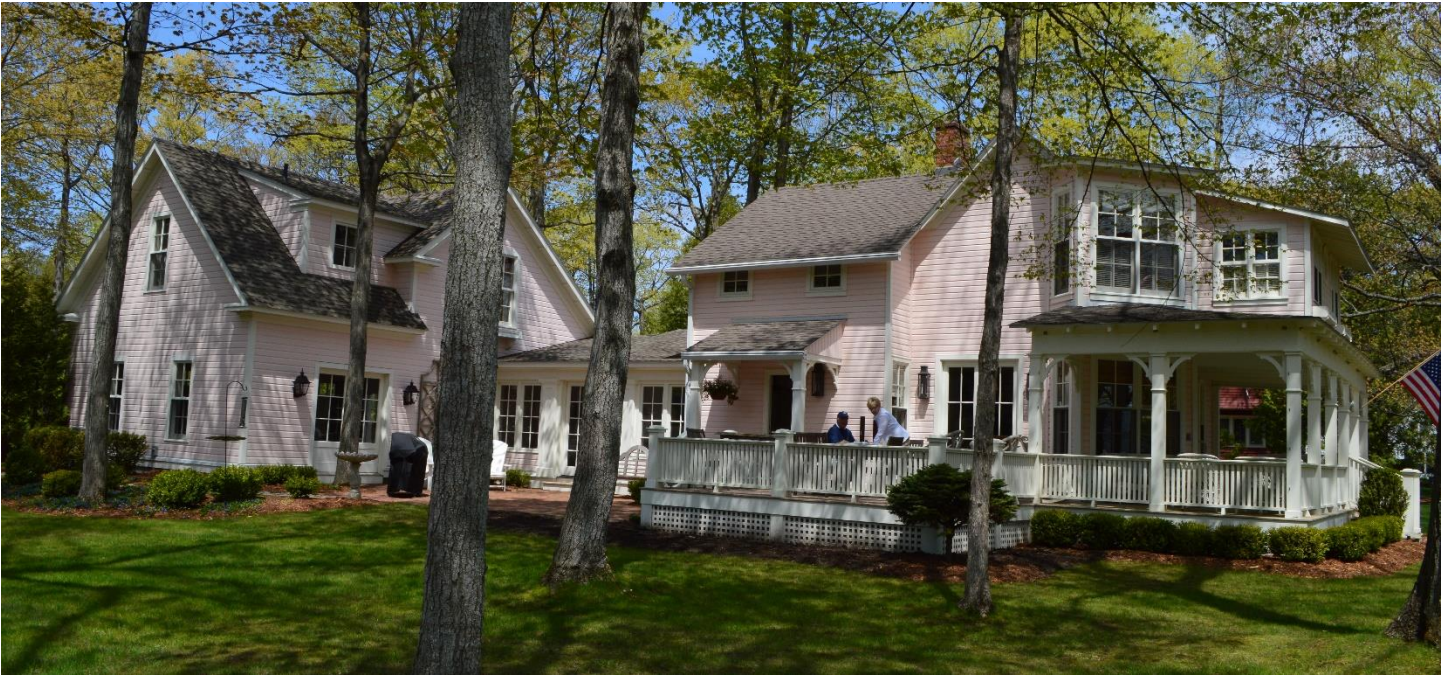
It appears that the original form of this cottage was a side gable, possibly with a rear ell, with a full width front porch that wrapped around the two-story bay placed at an angle on the southeast corner. It is likely that the part of the second floor which projects over the front porch was originally a second floor porch that was later enclosed. The new beveled siding is similar to what was previously on the cottage.

- Side gable two-story massing with rear ell and corner two-story bay placed at an angle to the main wall.
- Full width front porch with shallow pitch roof, posts and brackets are not original

The cottage appears to be in good repair with no apparent issues.
