BELVEDERE CLUB 2019 ARCHITECTURAL INVENTORY

Site: 137

Year Built c. 1890

Architectural Style Queen Anne

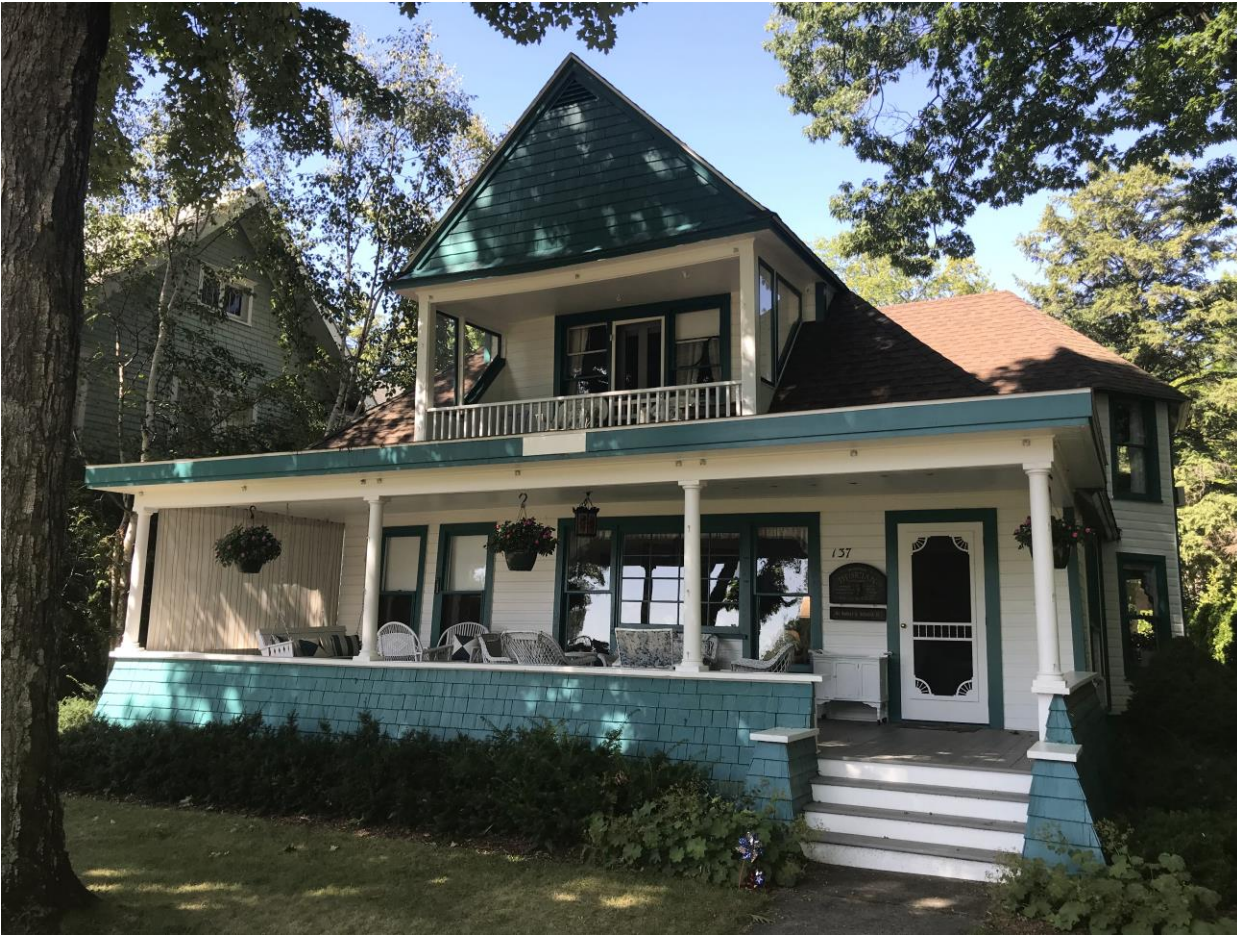
The one-and-a-half story cottage with its steeply pitched complex roof has a gable front wall dormer with a projecting gable creating a second-floor front porch. The full width front porch has shingle clad knee walls supporting Doric columns which may be an alteration from the 1910s. The multi-sided bay with hip roof on the north elevation and side porch to the rear are both indicative of the Queen Anne style.

- Complex roof with gable front wall dormer creating second floor front porch.
- Full width front porch with shingle knee walls supporting Doric columns and shingled wing walls at front steps.
- Multi-sided two-story bay on north side with hip roof.
- Shingle siding in gable front.

The cottage appears to be in good repair with no apparent issues.
