BELVEDERE CLUB 2019 ARCHITECTURAL INVENTORY

Site: 139

Architectural Style Prairie style

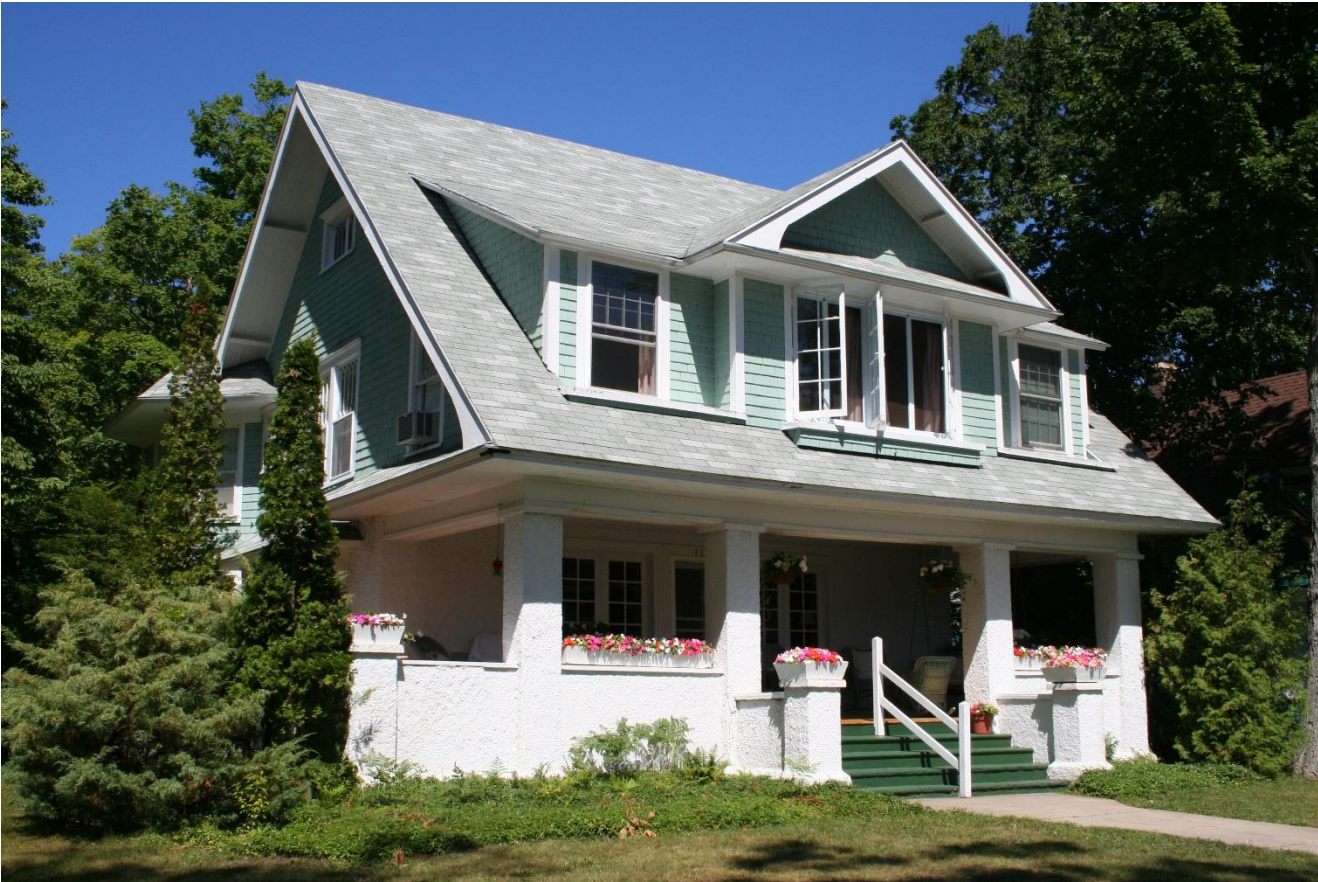
The steeply pitched side gable roof with shed roof dormer which has a projecting center gable over the deep front porch is typical of Prairie style massing. The stucco first floor and shingled second floor, along with the full width front porch with its stucco clad knee walls and pillars are also indicative of the style.

- Steeply pitched side gable roof with shed roof dormer with a projecting central gable with decorative bargeboard. Deep overhangs with brackets.
- Full width front porch with stucco clad knee walls and piers, central steps with stucco wing walls.
- Stucco first floor and shingle sided second floor.
- Bay window on south side with diamond pane windows. Upper floor windows with arched pattern muntins in upper sash and window trim.

The cottage appears to be in good repair with no apparent issues.
