BELVEDERE CLUB 2019 ARCHITECTURAL INVENTORY

Site: 141 Historic Name N/A

Year Built 1904

Architectural Style Shingle style

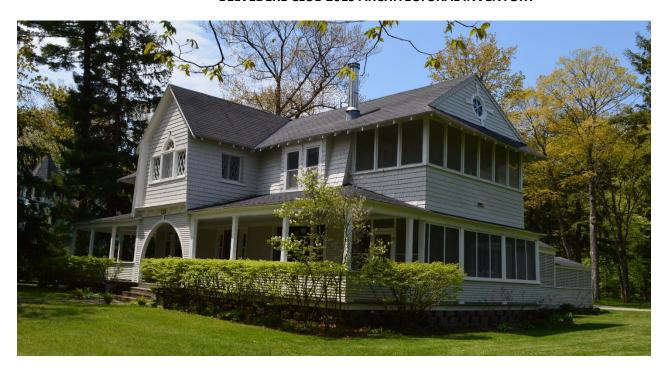
The cross-gable horizontal massing of this two-story cottage with its clapboard and shingle cladding, deep porches, and deep eaves with carved brackets, in addition to the large arch on the front porch are all characteristic of the Shingle style. The front gable with angled sides and Palladian window with diamond panes and wood trim, as well as the round window in the north gable end are also indicative of the style.

- Cross-gable roof with gable front with angled sides extending over the front porch, deep eaves with carved brackets and horizontal massing.
- Full width front porch with clapboard knee walls, Doric pillars, and large central arch with wood keystone, wood trim above and central front steps.
- Clapboard sided first floor and shingle sided second floor.
- Palladian window with diamond panes in gable front, round window with wood trim in north gable. The first-floor windows with the larger lower sash are typical of the Shingle style period.
- Sleeping porches in north and south wings.

The cottage appears to be in good repair with no apparent issues. The cottage retains most of its original features.
