BELVEDERE CLUB 2019 ARCHITECTURAL INVENTORY

Site: 145

Year Built c. 1908

Architectural Style Colonial Revival

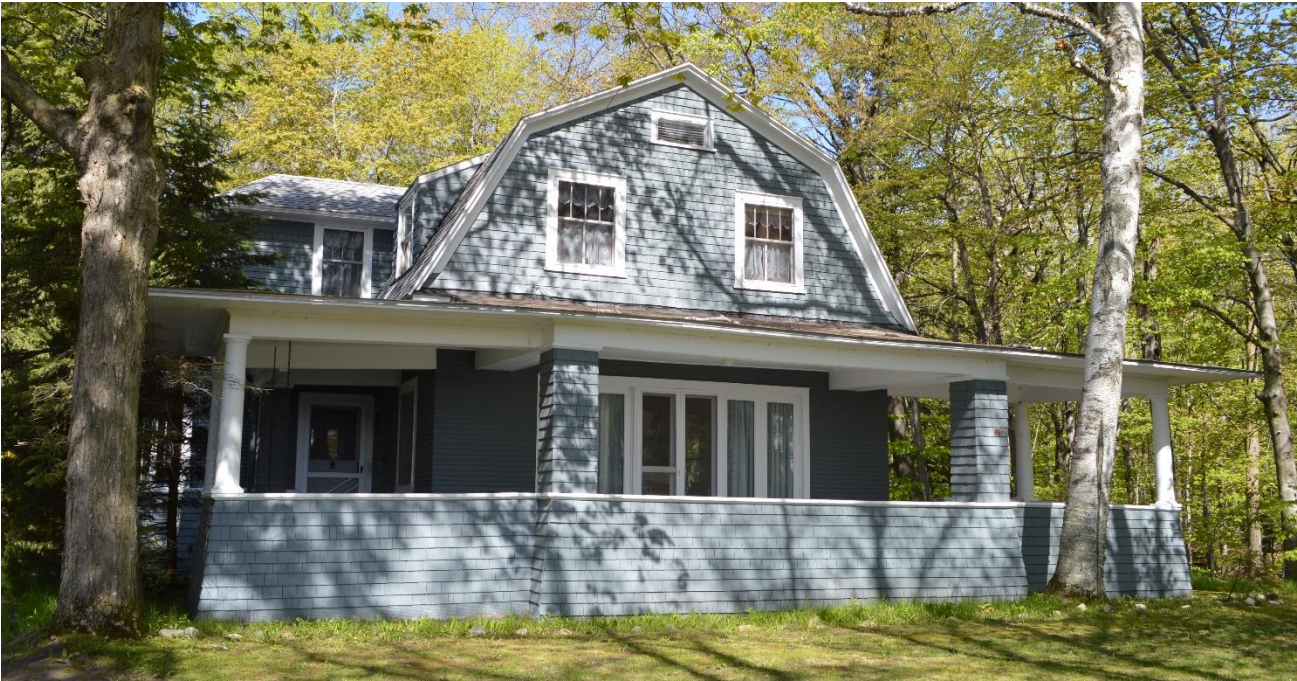
The gambrel front two-story cottage has an unusual feature in that the cross-massing ends in multi-sided towers on the north and south sides. The narrow clapboard cladding at the first floor and shingle siding at the second floor and on the full width front porch is usually found on examples of the Prairie style, as is the shingle clad pillars in the center of the porch. There are Doric columns at the corners of the porch. The four over two window configuration appears to be original.

- Gambrel roof facing front with shed roof dormers and cross wings ending in multi-sided two-story tall bays.
- Deep full width front porch with shingle sided knee wall and central pillars, Doric columns at corners.
- Narrow clapboard at first floor, shingle siding at second floor.
- Four over two window configuration.
- Rear sleeping porch with shallow roof and carved brackets.

The cottage appears to be in good repair with no apparent issues.
