## BELVEDERE CLUB 2019 ARCHITECTURAL INVENTORY

**Site:** 208

**Historic Name** Lakeview

**Architectural Style** Queen Anne

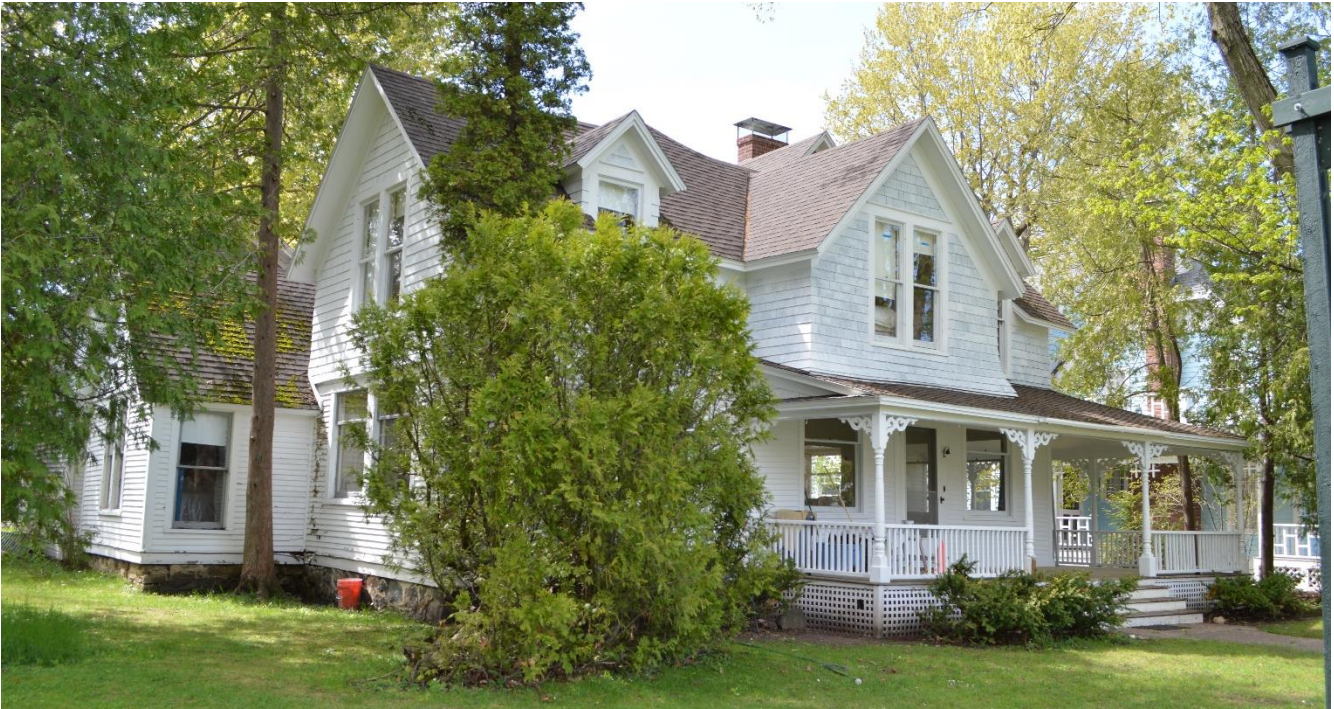
- Side gable roof with projecting gable front with flared walls. Gable front wall dormers.
- Wrap around front porch with turned posts, carved brackets and railing.
- First floor windows with a short upper sash and large lower sash and one-over-one windows at the second floor.
- Narrow clapboard siding at the first floor and shingle siding at the second floor.

The cottage appears to be in good repair with no apparent issues although the large shrubbery that touches the sides could cause moisture damage in the future. Moss is growing on portions of the roof. It retains much of its 1907 appearance.

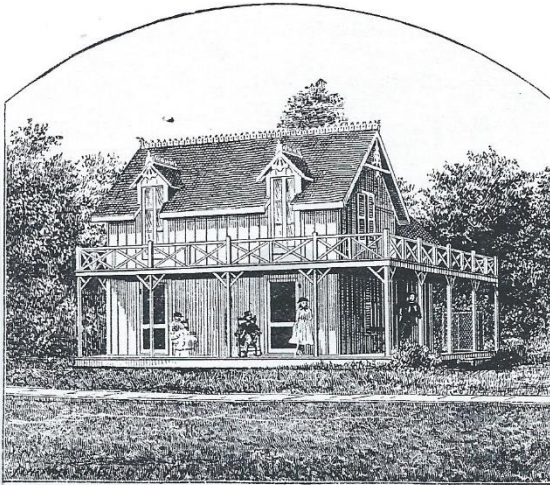
1887

"LAKEVIEW."  
I. D. BIXBY, KALAMAZOO, MICH.
