BELVEDERE CLUB 2019 ARCHITECTURAL INVENTORY

Site: 407 Historic Name N/A

Year Built c. 1890

Architectural Style Shingle style

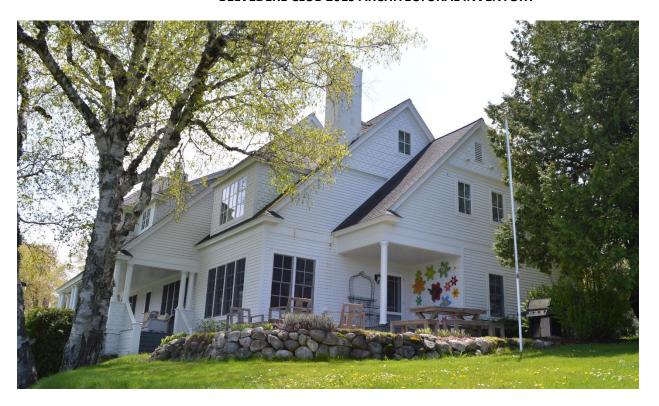
The steeply pitched side gable roof that overhangs the first floor creating a recessed front and rear porches, along with shed roof dormers are all indicative of the Shingle style. The combination of narrow clapboard and shingle siding and grouped Doric columns on shingle sided knee walls around the porches are also characteristic of the Shingle style. Originally the hip roof dormer in the center of the front elevation was a second-floor porch with shingle sided knee walls and paired Doric columns.

- Two-and-a-half story steeply pitched side gable roof and shed roof dormers overhanging the first floor creating recessed front and rear porches.
- Shingle sided knee walls supported grouped Doric columns on the front and rear porches.

The cottage appears to be in good repair with no apparent issues.
